Eurasian Water-milfoil (*Myriophyllum spicatum*)
Pre/Post Herbicide and EWM Bed Mapping Surveys
Big Trade Lake – WBIC: 2638700
Burnett County, Wisconsin

Endangered Resource Services, LLC
Matthew S. Berg, Research Biologist
St. Croix Falls, Wisconsin
May 15-16, June 18, and August 29, 2020

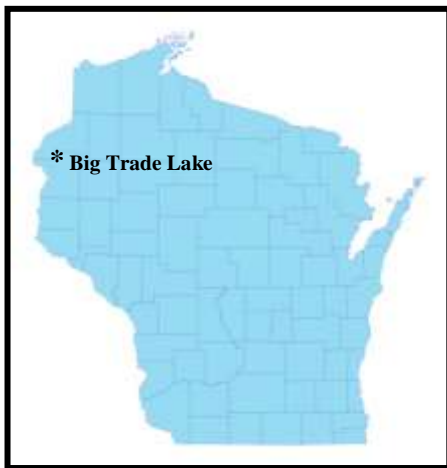
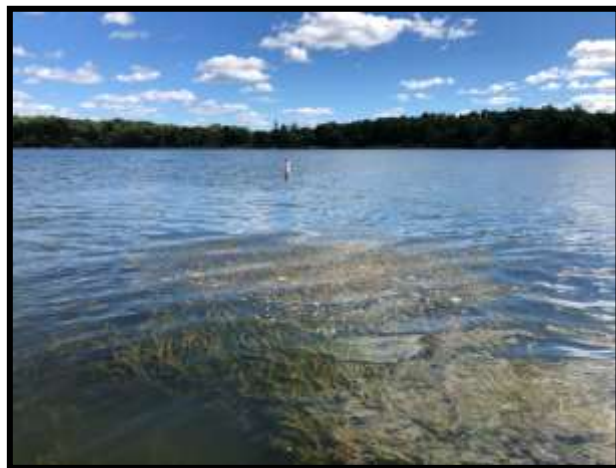
Canopied Eurasian water-milfoil bed on "Kid Rock" (8/29/20)

Bed 12: “Kid Rock” had no EWM during the fall 2019 survey or the 2020 pretreatment survey so it was eliminated from treatment consideration. By late August, a small but solid canopied mat had reformed, and we observed prop-clipped fragments throughout the area.

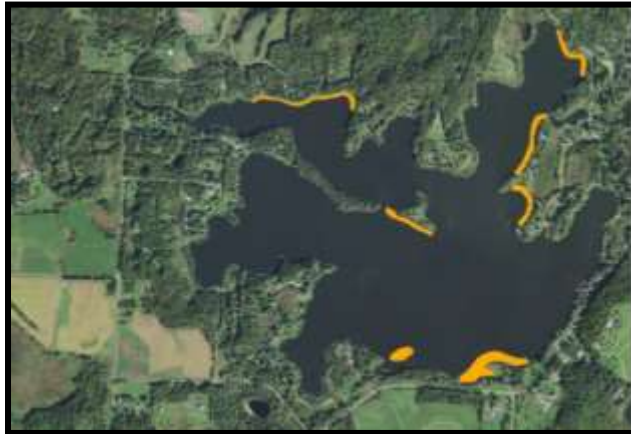
Figure 1: 2020 Final EWM Treatment Areas

Initial expectations were to treat nine beds for Eurasian water-milfoil using liquid 2,4-D (Shredder Amine) at a concentration of 3.5ppm (Figure 3) (Appendix I). Following the pretreatment survey, it was decided to eliminate the midlake rock bars (Areas 6 and 7), but maintain all other areas as planned. This was a reduction of 2.81 acres (-21.10%) over initial expectations (Table 1).

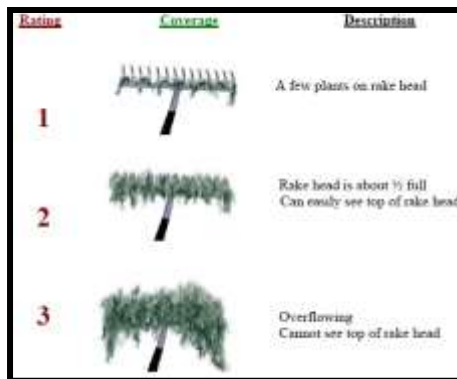
Figure 2: Rake Fullness Ratings

During the surveys, we located each point using a handheld mapping GPS unit (Garmin 76CSx) and used a rake to sample an approximately 2.5ft section of the bottom. All plants on the rake were assigned a rake fullness value of 1-3 as an estimation of abundance, and a total rake fullness for all species was also recorded (Figure 2). Visual sightings of EWM and CLP were noted if they occurred within 6ft of the point; however, visuals of other species were not recorded as they do not figure into the pre/posttreatment calculation. In addition to plant data, we recorded the lake depth using a metered pole and the substrate (bottom) type when we could see it or reliably determine it with the rake.

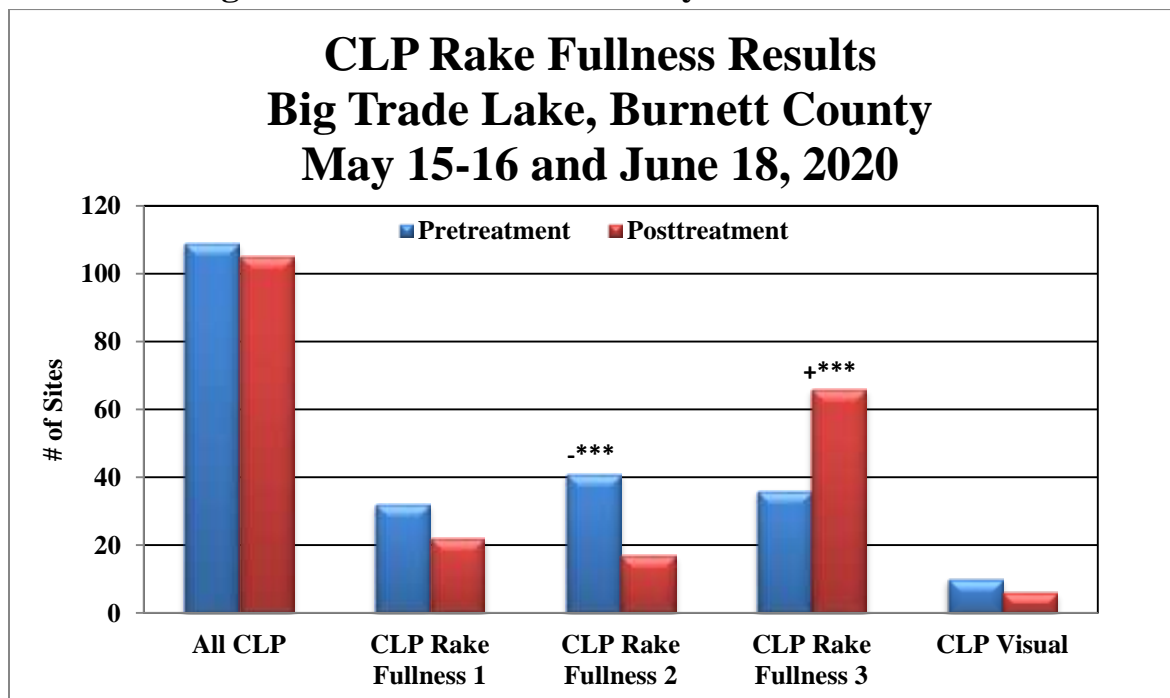
Figure 9: Pre/Post Changes in CLP Rake Fullness

Significant differences = * $p<0.05$, ** $p<0.01$, *** $p<0.001$

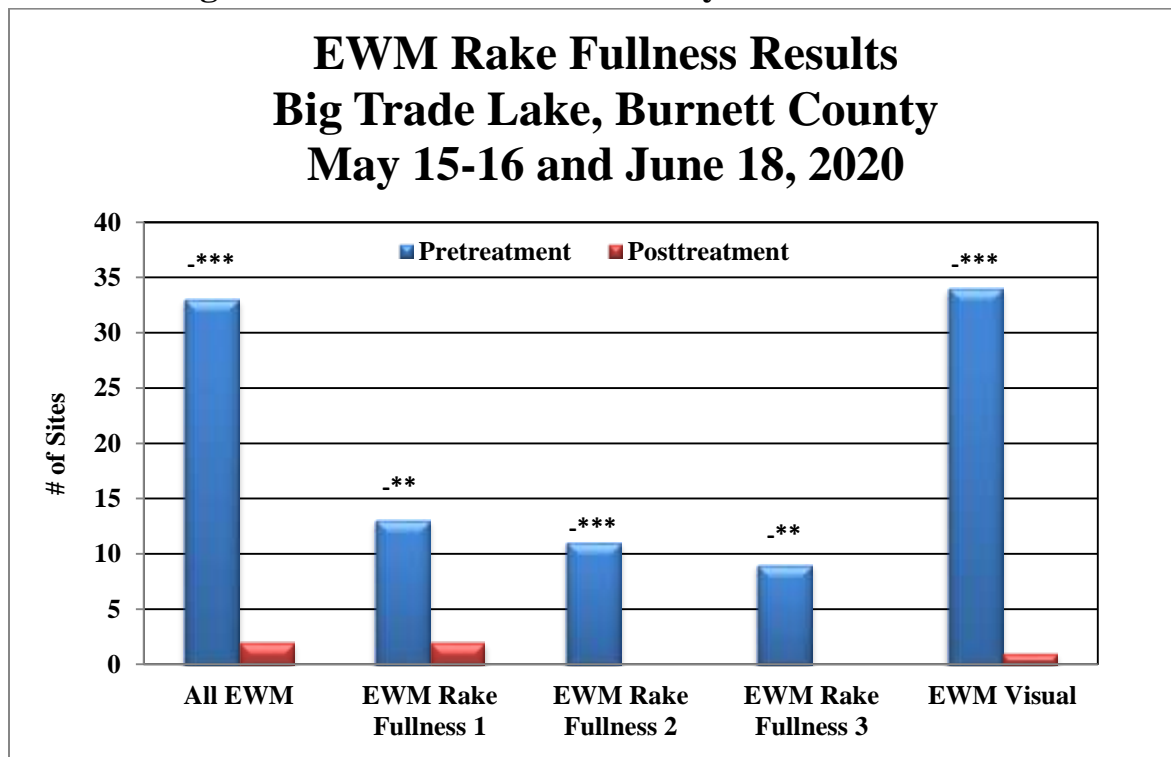
Figure 11: Pre/Post Changes in EWM Rake Fullness

During the posttreatment survey, EWM was present at a two points (2.6% coverage) both with a rake fullness of one. We also documented it as a visual at a single point (Figure 10). **Our results demonstrated a highly significant decline ($p<0.001$) in total EWM density, distribution, rake fullness 2 and visual sightings; and a moderately significant decline ($p=0.002/p=0.004$) in rake fullness 3 and 1 (Figure 11).**

Significant differences = * $p<0.05$, ** $p<0.01$, *** $p<0.001$

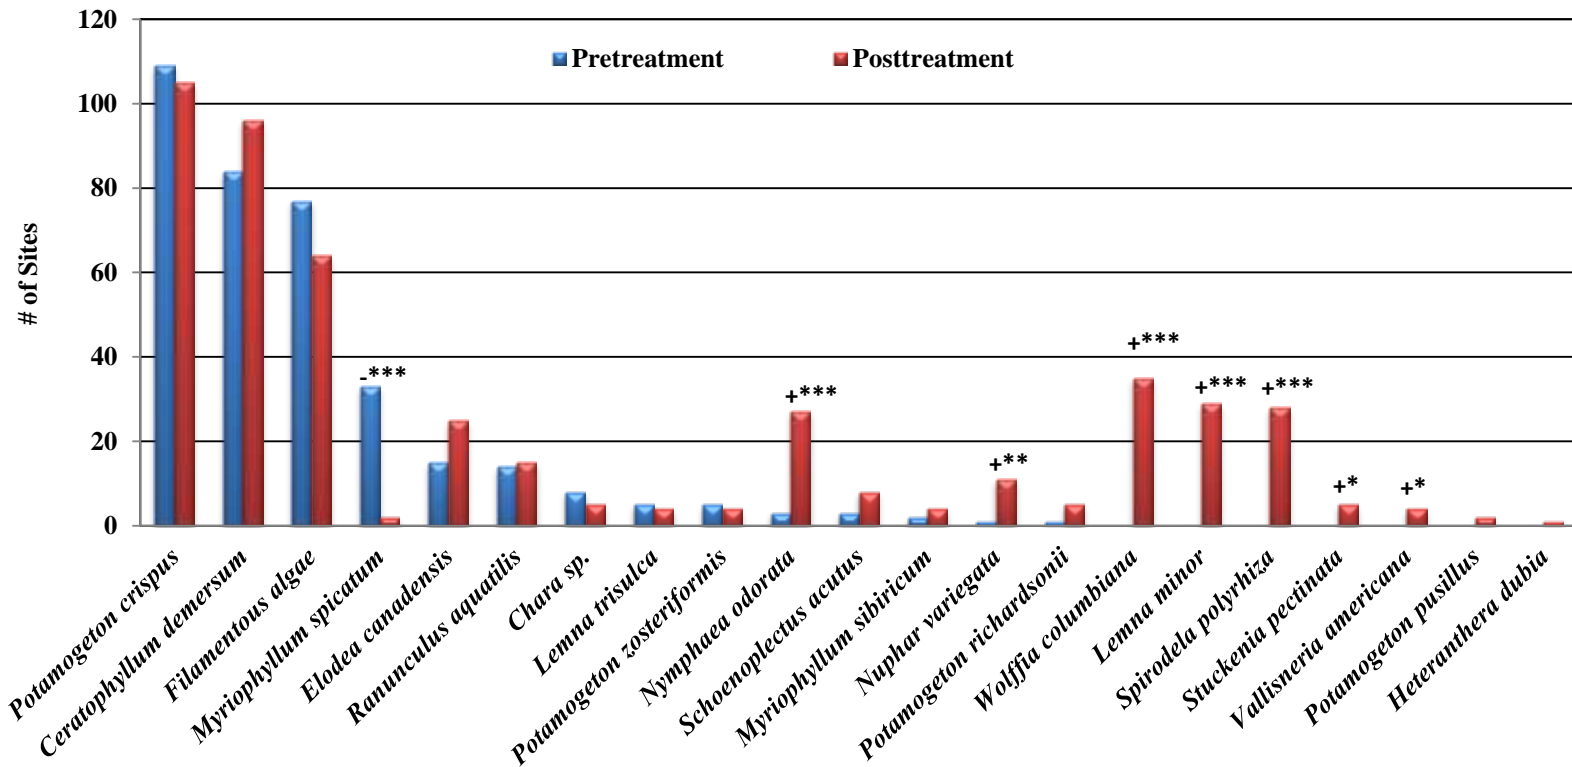
Figure 14: Pre/Post Macrophyte Changes

Other than EWM, no species experienced a significant decline posttreatment, but many expanded their range. Specifically, White water lily (*Nymphaea odorata*), Common watermeal (*Wolffia columbiana*), Small duckweed (*Lemna minor*), and Large duckweed (*Spirodela polyrhiza*) underwent highly significant increases; Spatterdock (*Nuphar variegata*) saw a moderately significant increase; and Sago pondweed (*Stuckenia pectinata*) and Wild celery (*Vallisneria americana*) had significant increases (Figure 14) (Maps for all native species from the pre and posttreatment surveys are available in Appendixes VI and VII).

Significant differences = * $p < 0.05$, ** $p < 0.01$, *** $p < 0.001$

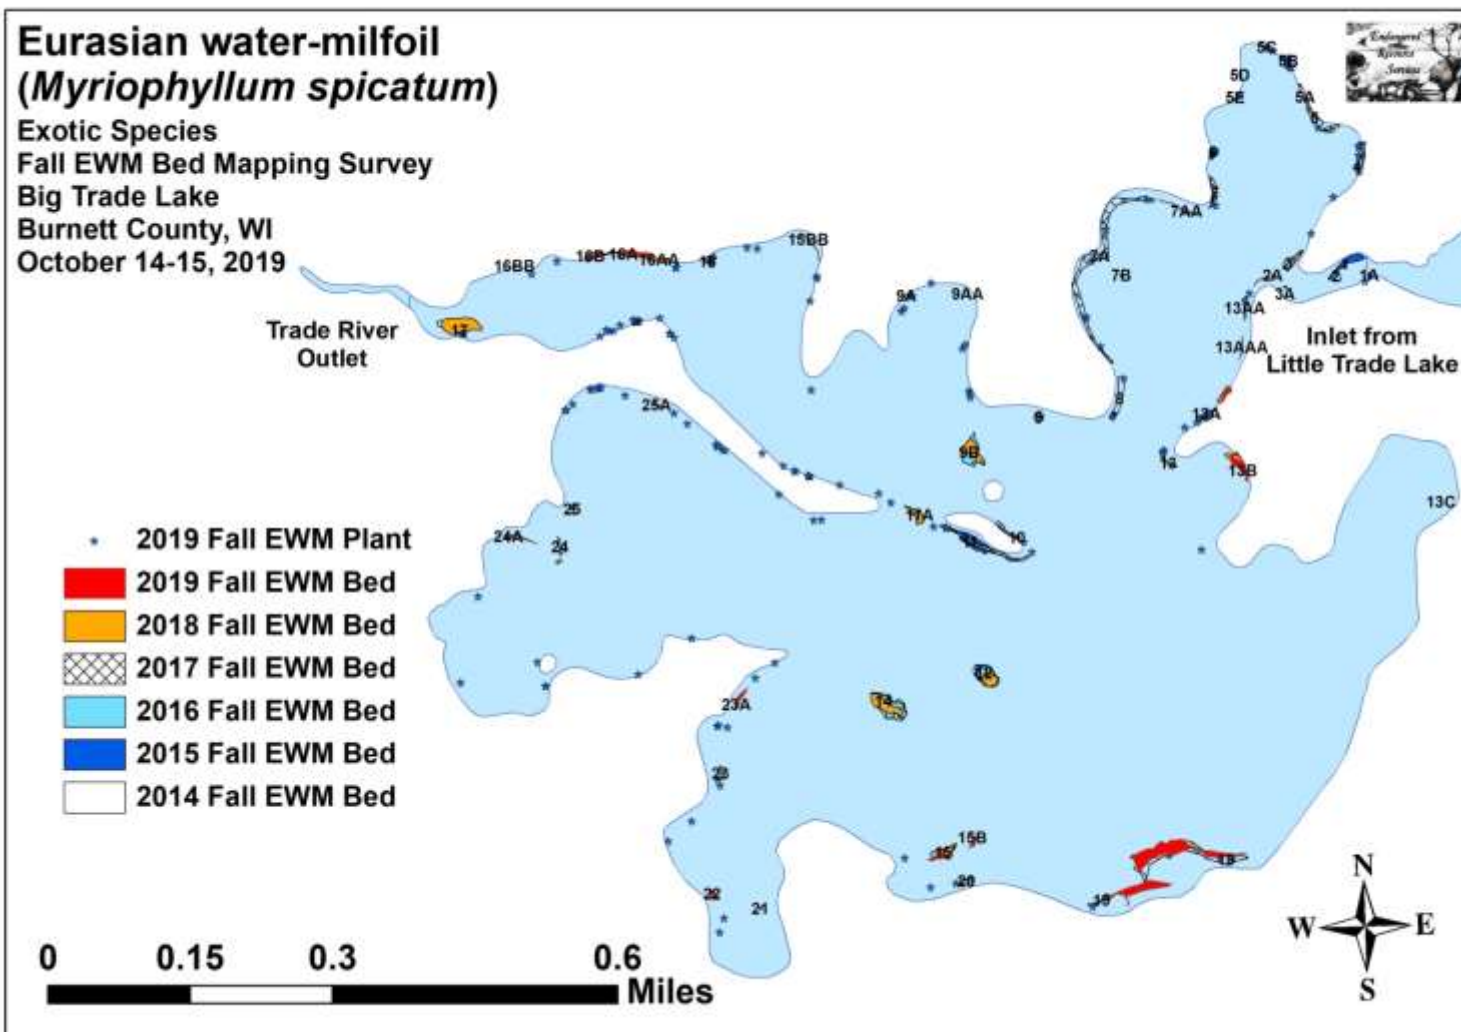
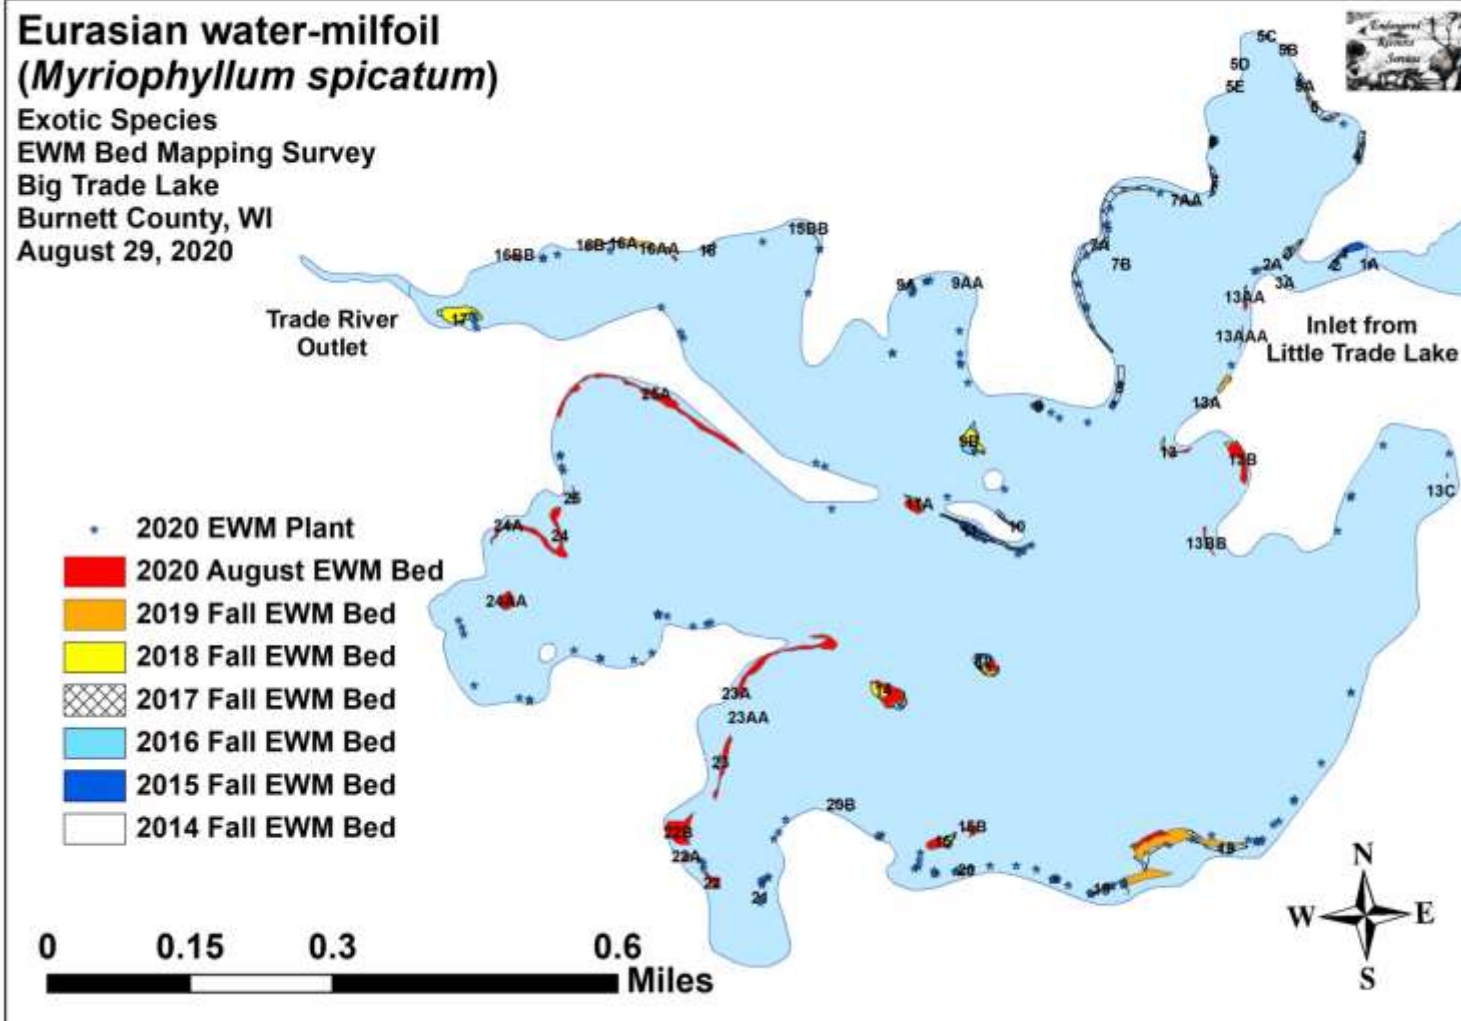
Exotic Species
 Fall EWM Bed Mapping Survey
 Big Trade Lake
 Burnett County, WI
 October 14-15, 2019

Eurasian water-milfoil *(Myriophyllum spicatum)*

During the August survey, we located and mapped 27 Eurasian-water milfoil beds ranging in size from <0.01 acre (Bed 13C) to 0.63 acres (Bed 25A) (Figure 15) (Appendix VIII). Collectively, they covered 3.38 acres (1.03% of the lake's surface area) (Table 5). This was an increase of 1.81 acres (+115.29%) from the 24 beds on 1.57 acres (0.48% of the lake's total surface area) we mapped in 2019. It also represented the highest total ever found on the lake (the previous high was in 2017 when we found 32 beds on 2.97 acres – 0.91% coverage) (Table 6). Outside of these areas, we marked 148 additional pioneer plants suggesting EWM is continuing to spread.
